Manhole Inspection Summary

Manhole # S43A__021MH

Insp Date: **2/25/10 11:59 AM**

Location Address: **Orleans st**

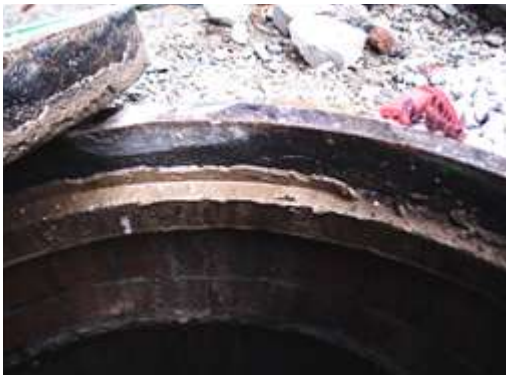
Defect 1

Frame Offset: **0** (in.) Condition: ☐ Sound ☐ Cracked ☒ **Leaks**

frame leaks

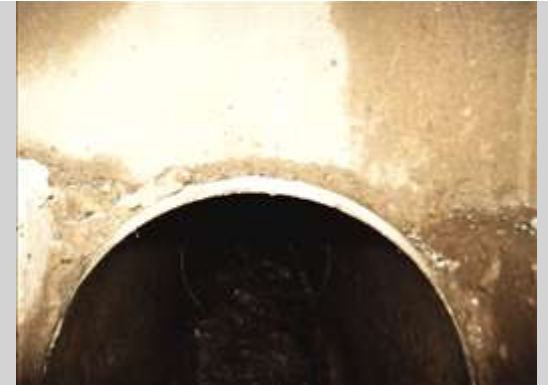
12 O'Clock Outflow

10 in. Circular Gravity Sewer
Pipe Out @ 12 O'Clock

Pipe Height: **14.4** (in.) Rod and Bar (Angled)
Pipe Material: **Clay** ☐ Pipe Lined
Invert Depth: **10.67** (ft.) Flow Characteristics: **Slow**
Deposits: ☒ None ☐ Mud ☐ Sludge ☐ Debris ☐ Grease
Silt Depth: (in.) Deposits Extent:
Infiltration: **None** Pipe Seal Cond: **Sound**
